Maschhoffs New Minden Site Plan - 130220

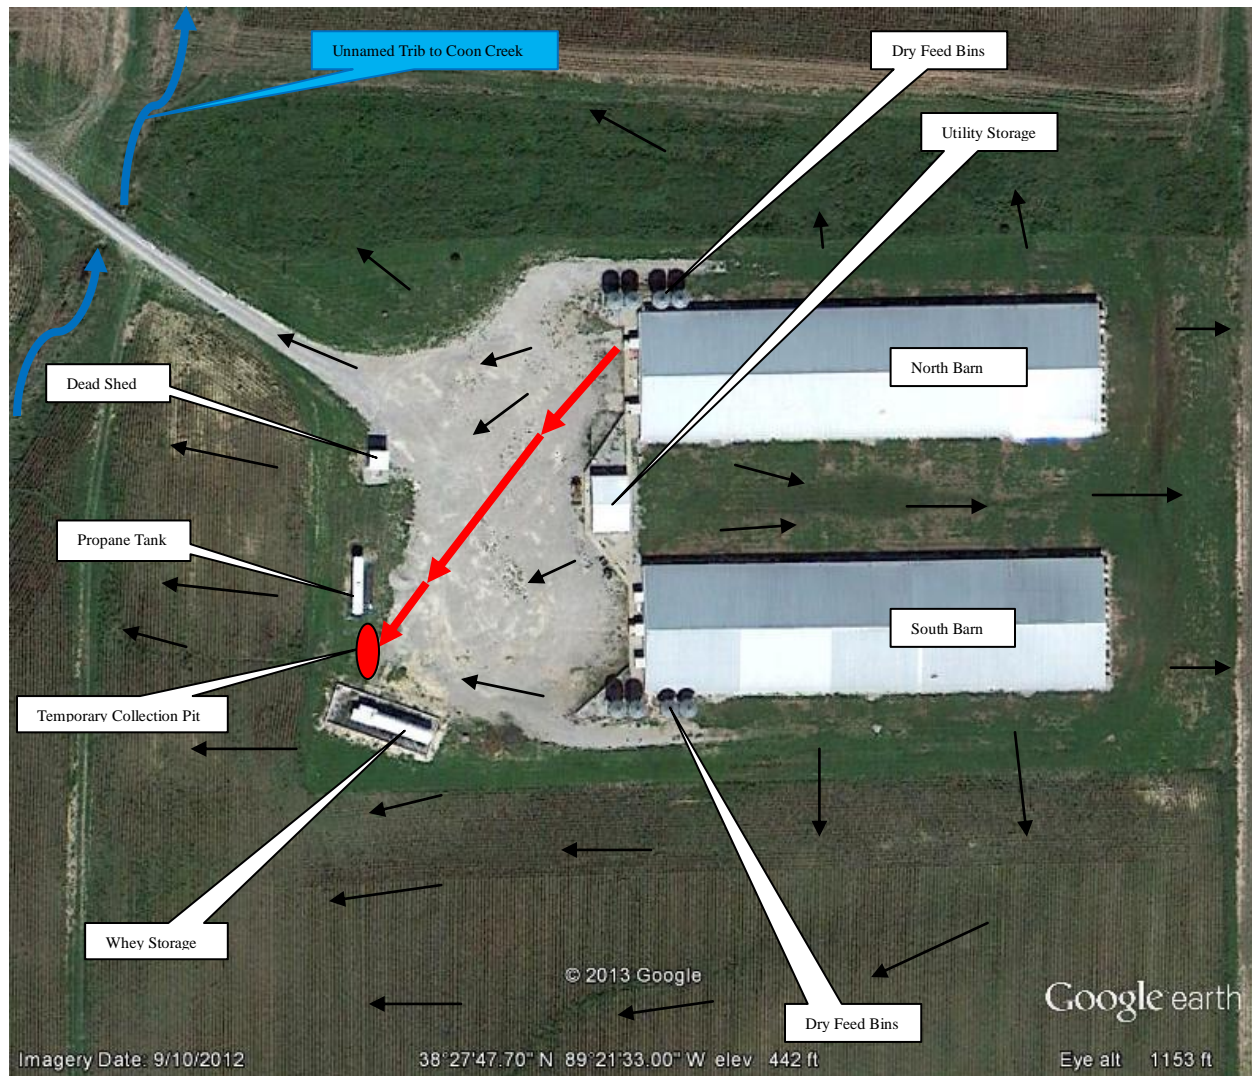
Black arrows show the direction of storm water drainage. Barns are labeled as shown. A broken pipe in the west end of the north room of the north barn allowed whey feed to exit the barn, run across the limestone lot, and pool at the southwest end of the lot as shown by the red arrows. A temporary pit was dug at the edge of the limestone lot as indicated by a red oval where the whey and freshwater flush was collected. Collected whey and freshwater was placed in the under floor deep pits for land application. No feed or affected freshwater flush appeared to leave the site. An unnamed tributary drains north as shown by the blue arrows and appeared unaffected. No discharge was noted at the time of inspection.
